**CANADIAN FORCES  
FLIGHT SAFETY INVESTIGATION REPORT (FSIR)**

**FINAL REPORT**

**FILE NUMBER:** 1010-130344 (DFS)

**AIRCRAFT TYPE:** CC130H-30 (CC130344)

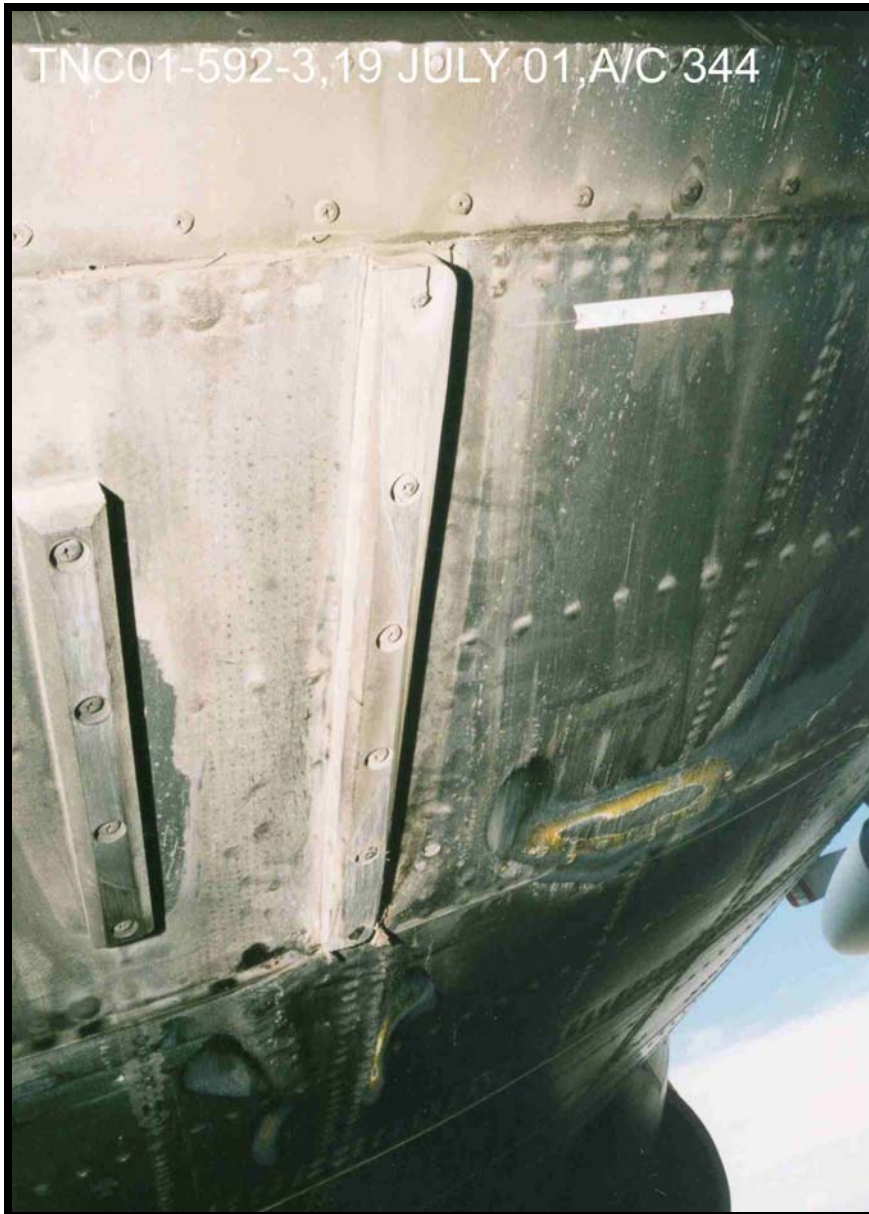
**Annex A: Photographs**

The right skid plate sustained extensive wear, as did the surrounding skin. The bulk of the structural damage was discovered inside the aircraft after the floorboards were removed. The RH lower fuselage longeron splice fitting between the cargo floor bulkheads was wrinkled and cracked. The bulkhead lower cap was buckled, and the "C"-shape stiffeners were cracked at the lower attachment point. The repair required a special engineering disposition, as this damage is not covered in the repair manuals. See Annex A for photos of the damage.

3.1.14 The aircraft struck the ground in a 3 degree right wing down attitude with a pitch attitude of 8°, an indicated airspeed of 114 Kts, and power at flight idle. The internal structures of the aircraft around the right side of the ramp hinge area sustained "C" category damage.
